Environmental Restoration Project Playa Tamarindo Culebra, Puerto Rico Phase I

Roberto A. Viqueira Ríos
Louis G. Meyer Comas
Protectores de Cuencas, Inc.
Paul Sturm
Ridge to Reefs, Inc.
19 al 23 de agosto de 2013

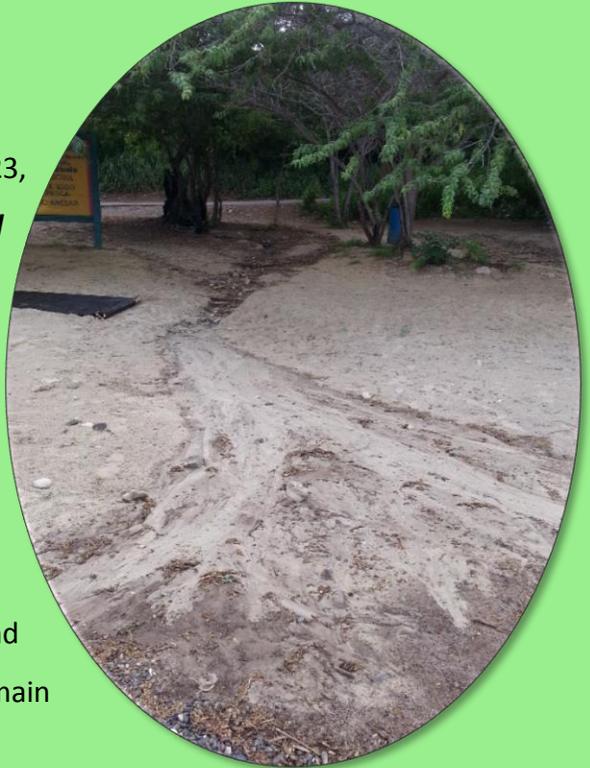
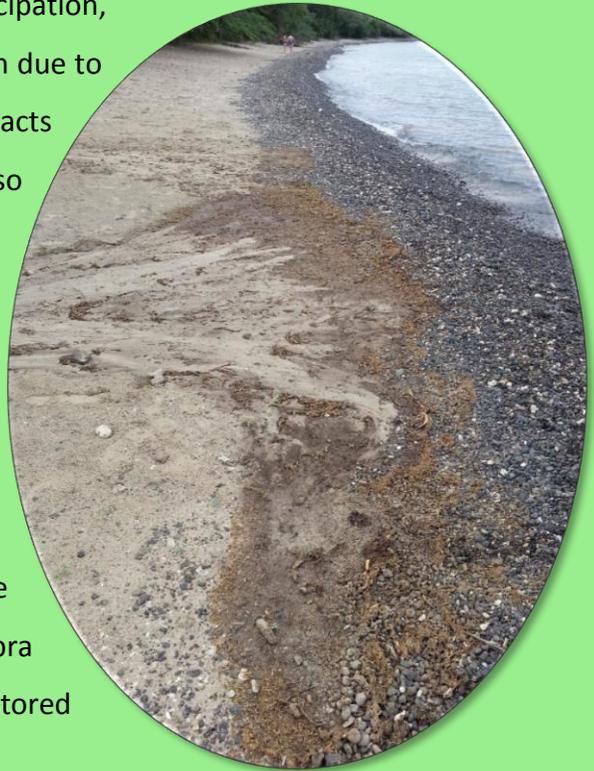
Area affected by runoff associated to the parking, previous to the restoration project.

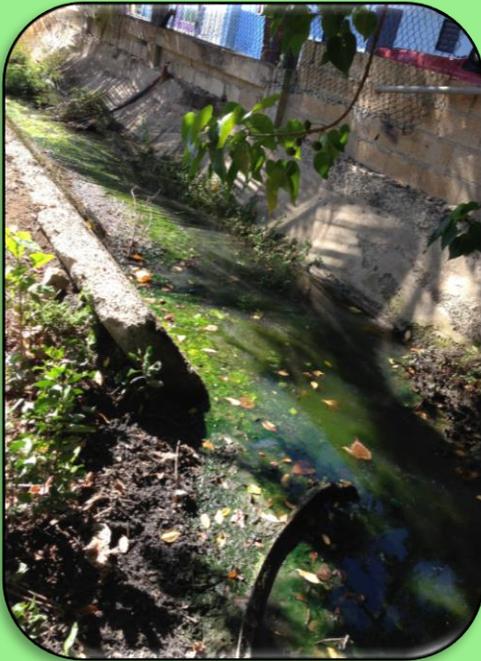
Drainage channel in Culebra.

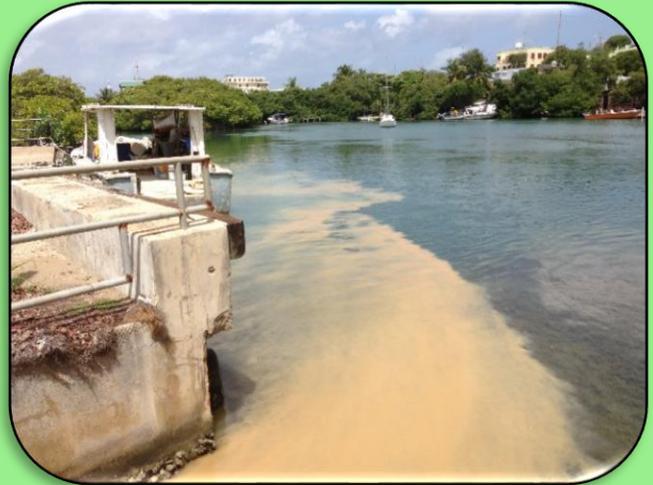
Sediment discharge to the Lobina Canal because of erosion from a dirt road after a water tank overflowed in Culebra.

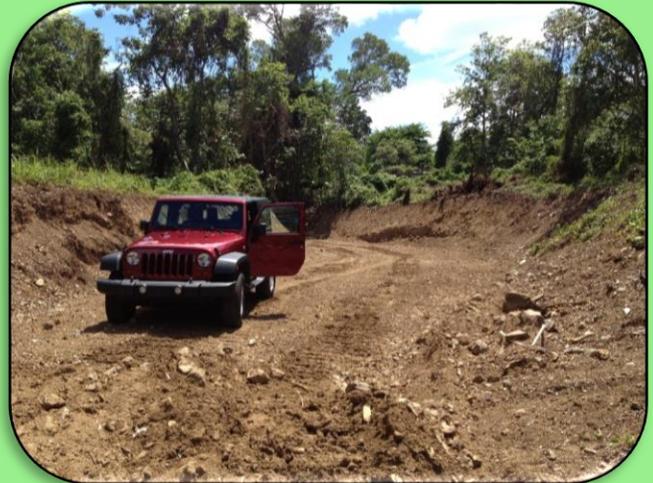
Culebra runoff channel enlarged and devoid of vegetation by the municipal administration of Culebra last before being restored through hydroseeding technique.

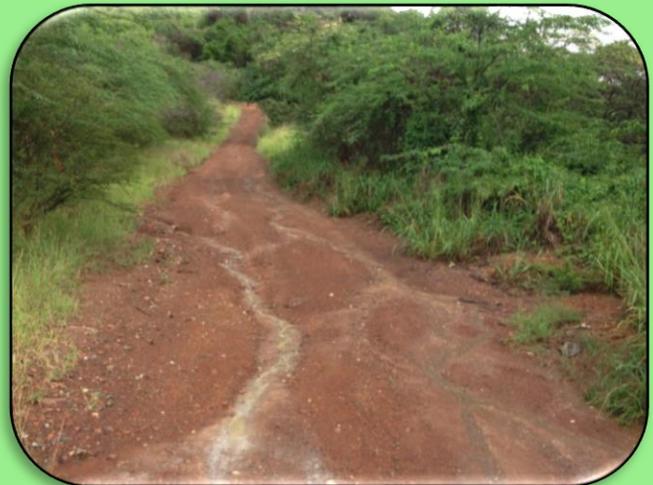
One of the many existing dirt roads in Culebra

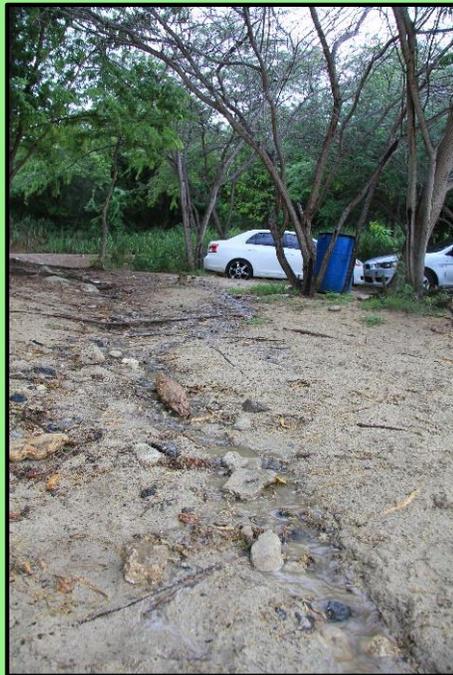
Parking area prior to restoration.

The problems of erosion and sedimentation in Tamarindo beach are mainly associated runoff coming from the dirt parking lot and access road to the beach that is only partially paved and in a critical state of disrepair with lots of exposed soil. The parking lot covers an area of approximately 160 m². Prior to the rehabilitation of the parking area, motor vehicles had direct access to the permanent vegetation areas of the beach and in several places, vehicles could get to the beach area, and sometime traversed the beach in the evenings.

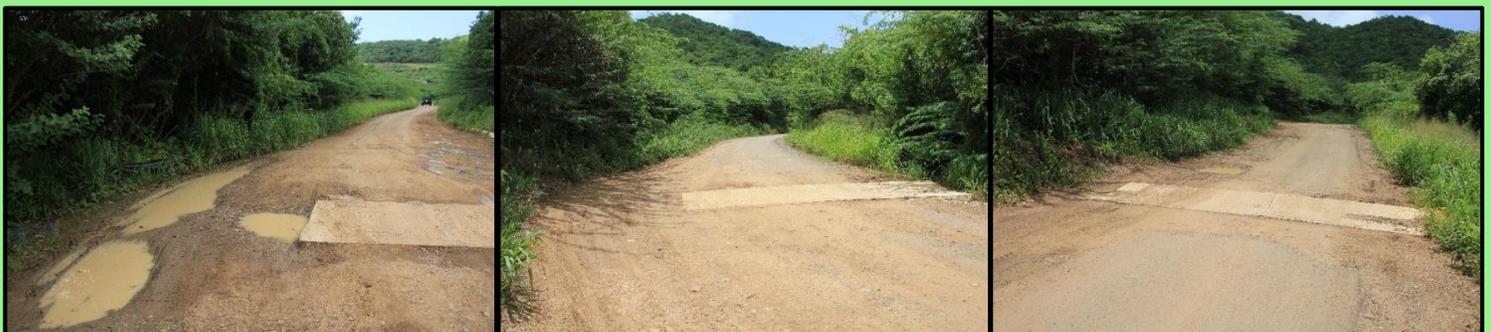
Current conditions to the road leading to Playa Tamarindo.

During the last municipal administration there were some attempts to pave the road and only stage culminated with concrete cross swales with exposed bare soil at both ends (which actually worsened sedimentation problems from the access road).

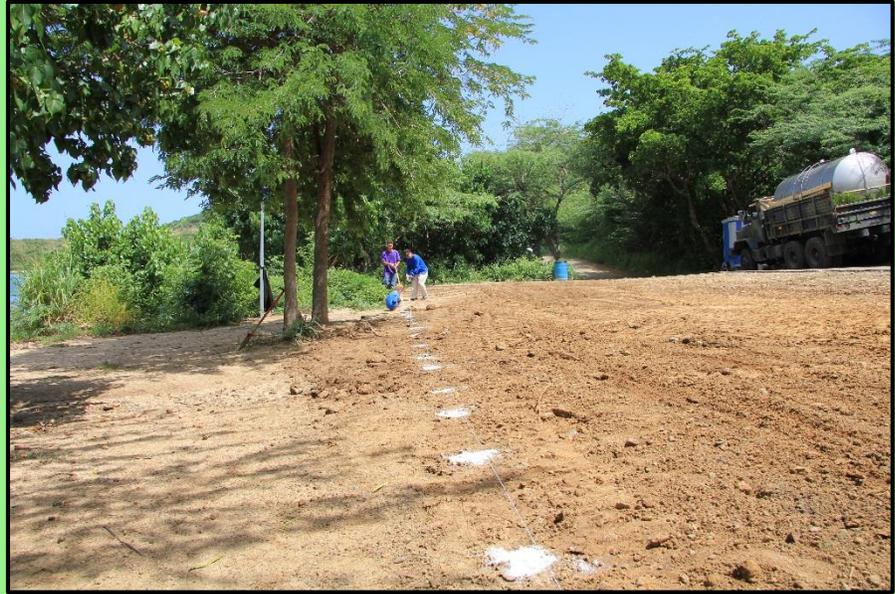
Process of demarcation and delimitation of the new parking area.

The procedure was, first, to delineate the parking area above the permanent vegetation zone of the beach. This delineation was conducted by installing wooden posts buried about 18 inches deep and fixed with concrete at base leaving about 30 inches pole to demarcate the area. Wooden posts were placed at a distance of three feet from

each other to prevent the passage of small vehicles such as golf carts that have become a major means of transportation in Culebra. Each pole was connected to each other by using 2x6 boards, which in turn, act as a barrier to keep in place the stone used to stabilize the parking lot.

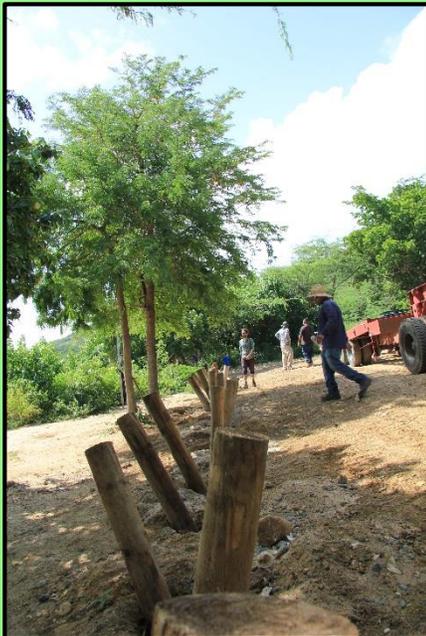
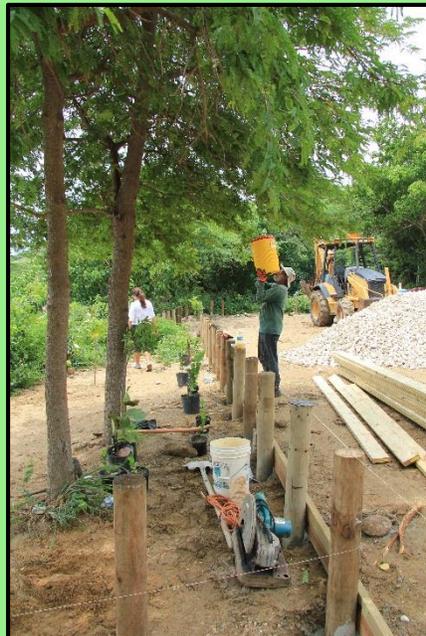
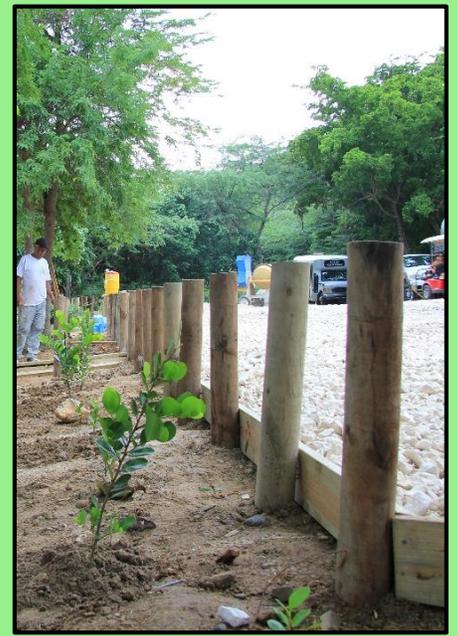
Process of creating the new parking area.

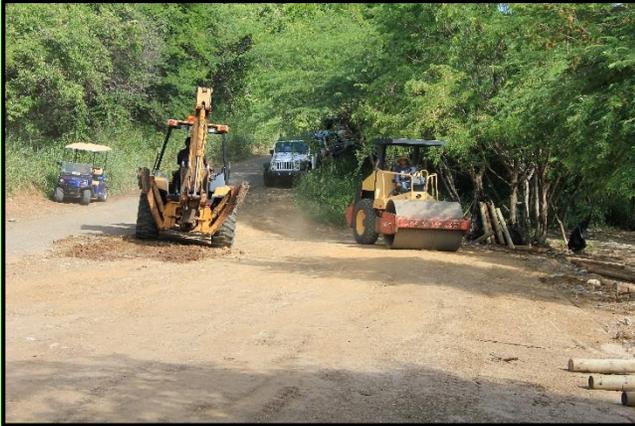
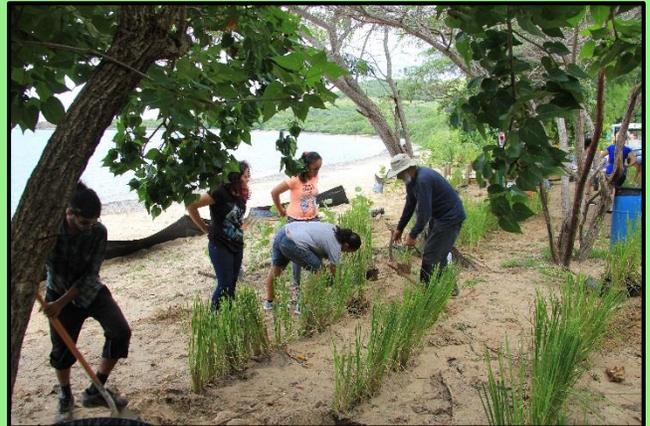
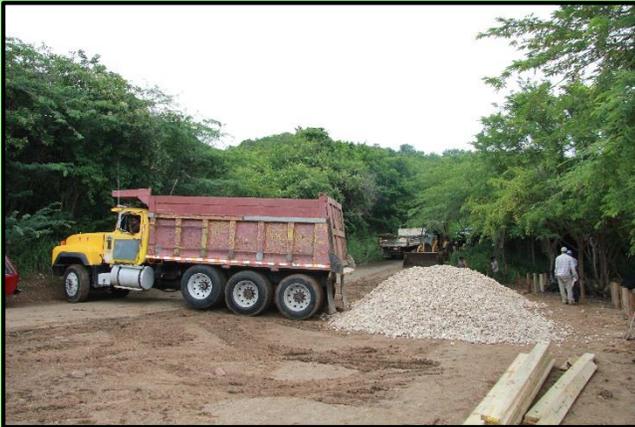
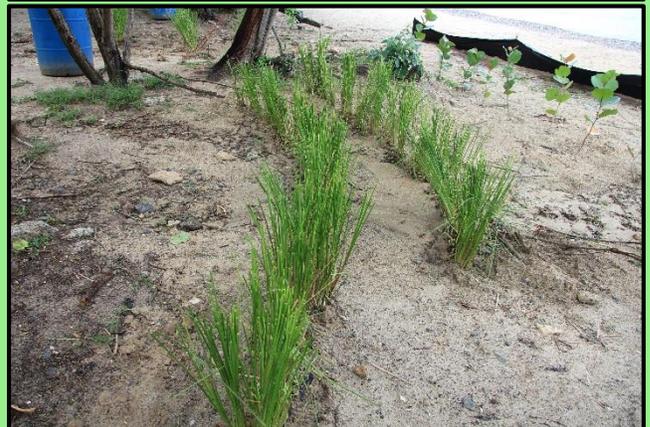
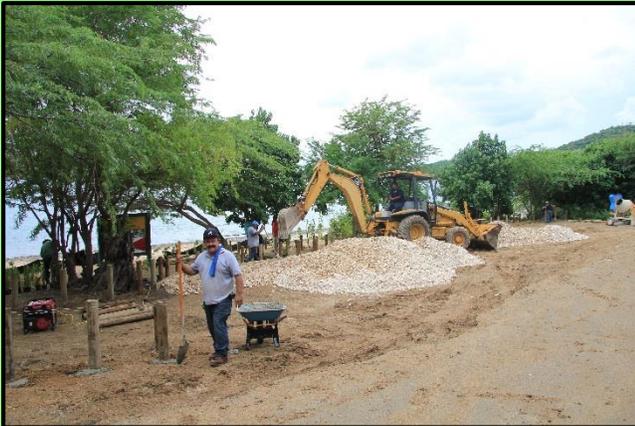
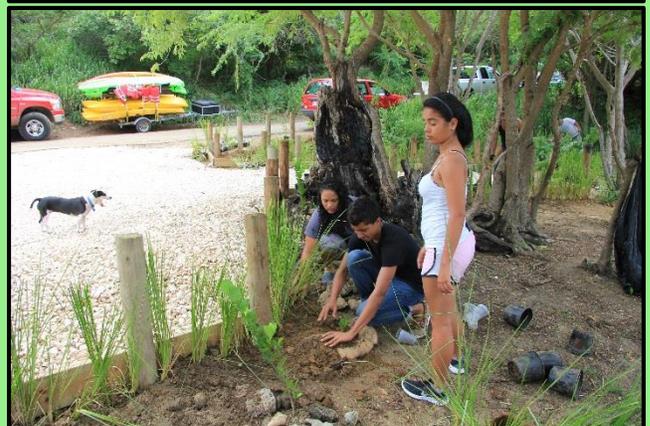
Parking stabilization process.

Second, stone was laid in the parking lot to promote infiltration and reduce surface water flows causing erosion during rainy periods. Approximately 60 m³ were used of A1 washed stone. The material used has the same specifications of the material that was approved by the DNER to stabilize coastal roads and trails in the Reserve International Guanica Dry Forest. The stone was compacted slightly using manual equipment to both maintain a safe walking surface and some degree of infiltration in the area. Prior to the placement of the stones the ground was leveled. Third, erosion control plants and infiltration galleries were added to enhance deposition of sediment from the runoff from the road and parking lot. 600 vetiver plants (*Vetiveria zizanioides*) were planted to reduce runoff and enhance sediment deposition. The vetiver has a dense and deep root system that intercepts surface runoff and reduces energy of the water and traps sediment. Fourth, the shoulder area of the road where most of the runoff was generated and conveyed now intercepts water through cross swales at five locations to break up flow paths and reduce concentrated flow of runoff over the historically dirt parking lot.

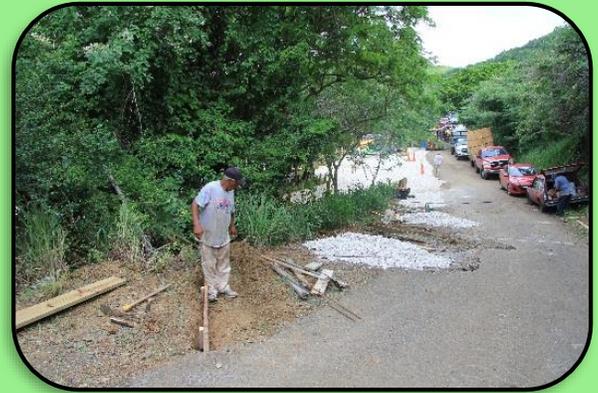
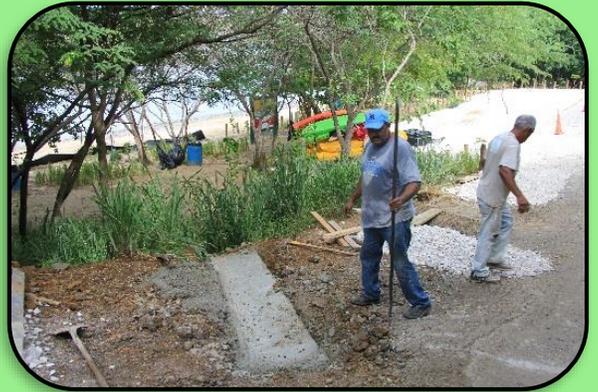
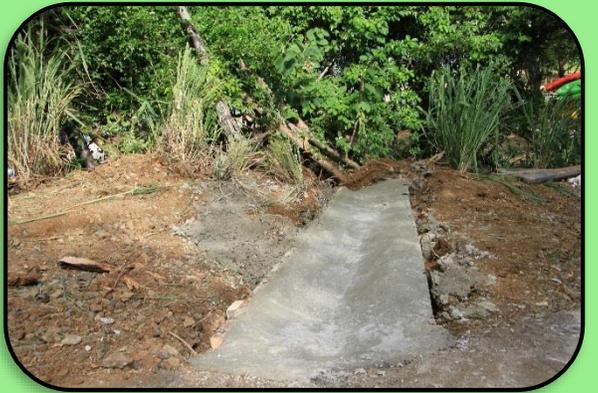
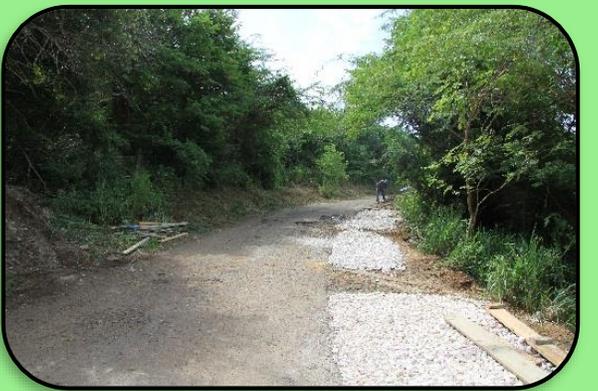
Improvements to the road drainage -- attenuation and flow reduction and redirection.

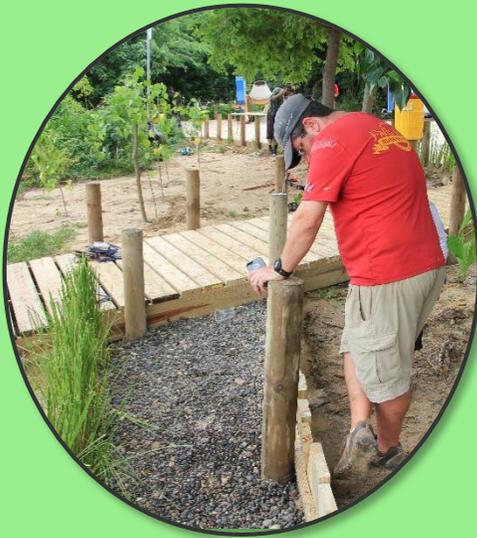
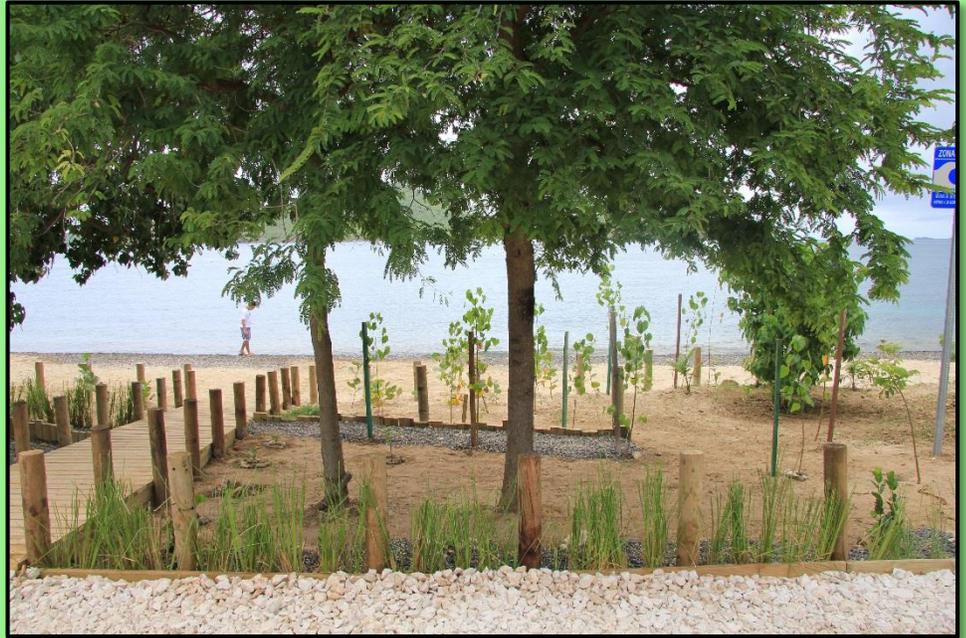
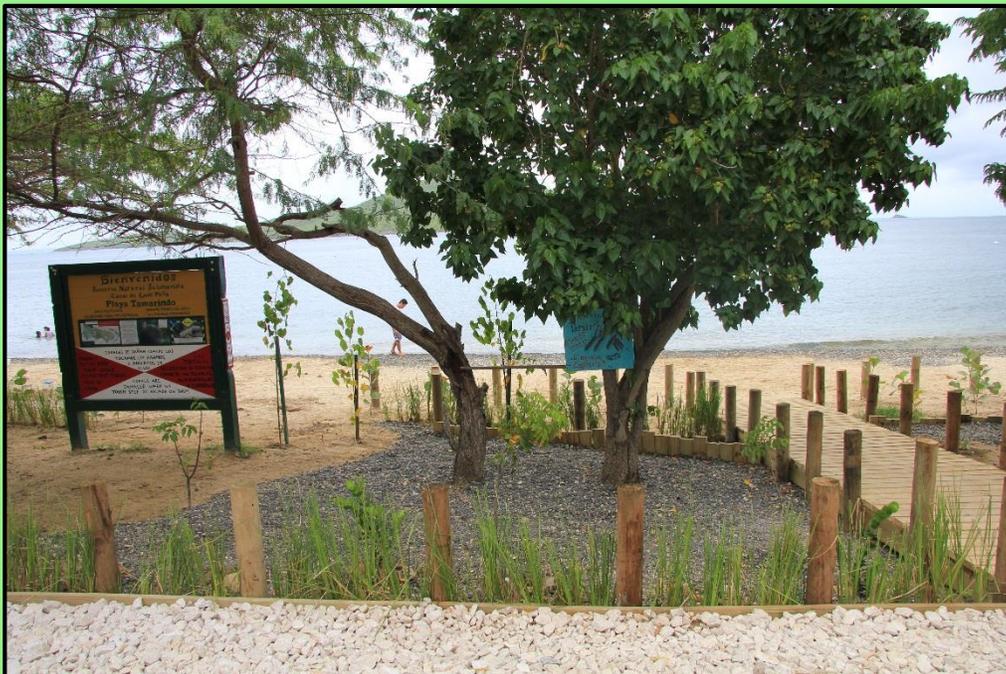
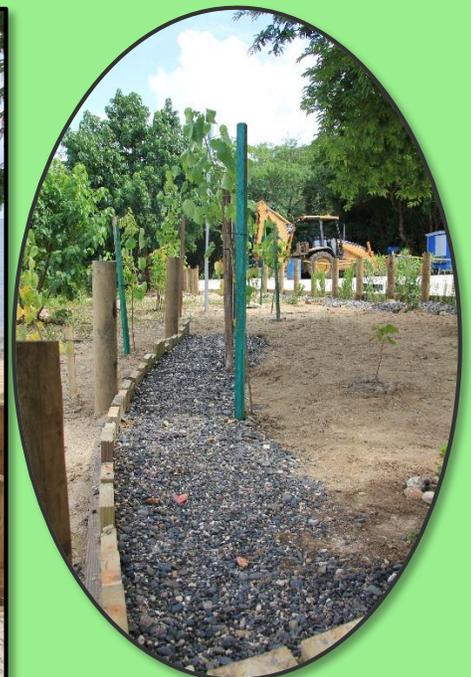
Images of bio-filters/infiltration galleries been built.

Fifth, we created two small bio-filters/infiltration galleries to treat runoff not infiltrated by the parking lot. The bio-filters were built with wood, sand and gravel. Temporary sedimentation measures (silt fence) controls were installed prior to construction and remained in place for the duration of the implementation.

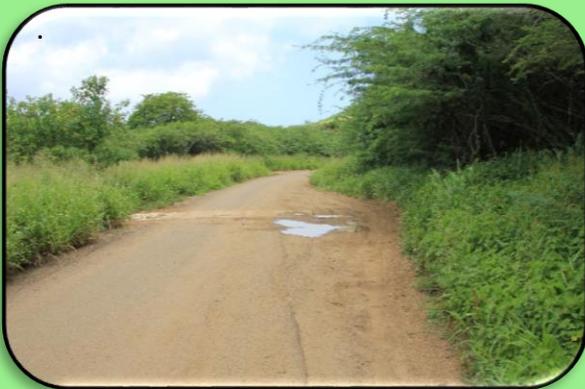
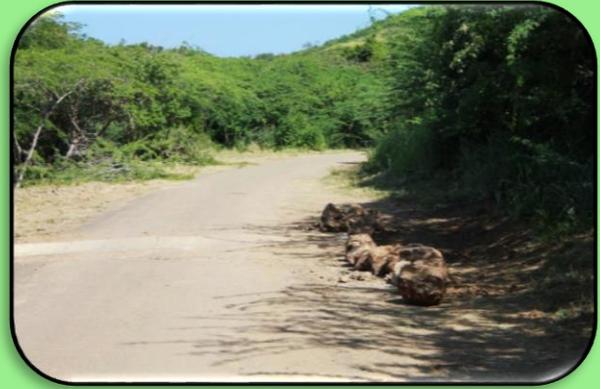
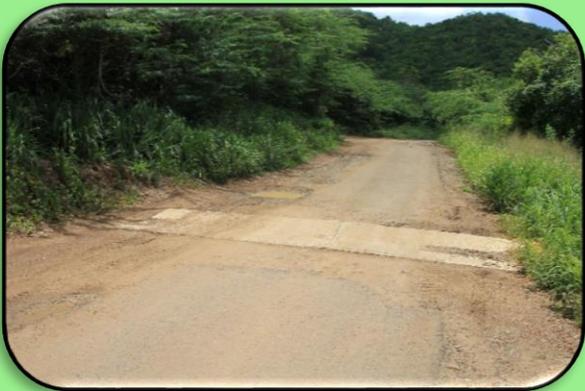
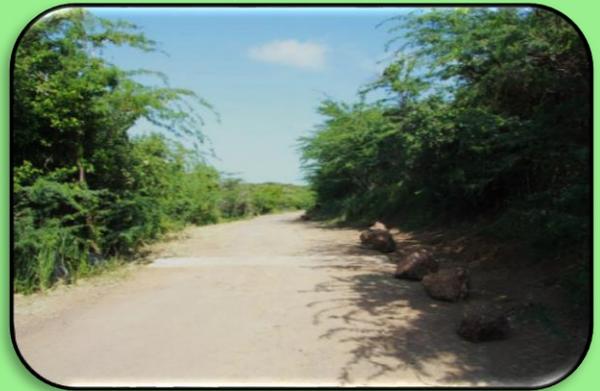
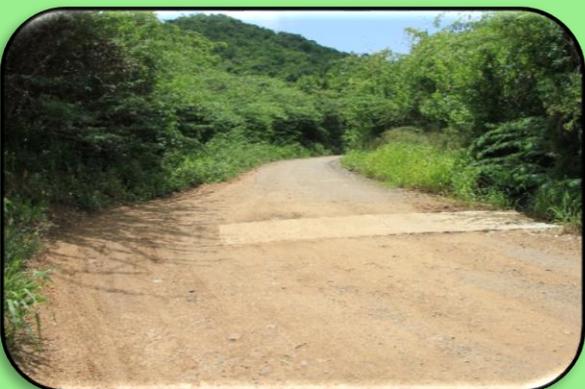
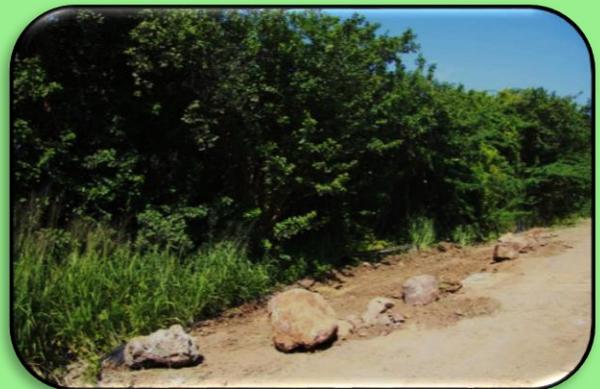
Images of erosion problems of the road and temporary measures to control erosion and sedimentation

Currently, the Municipal Administration of Culebra is finalizing details to complete the paving of the road. The second phase of the Environmental Restoration project involves the reforestation of the Tamarindo access road and creating rain garden catchments at many of the cross swales along the road. This final phase of the project will begin during the month of October or November depending on rainfall. As a precaution, large rocks were placed to prevent the passage of vehicles on the exposed soil areas and areas were created to temporarily trap sediment.

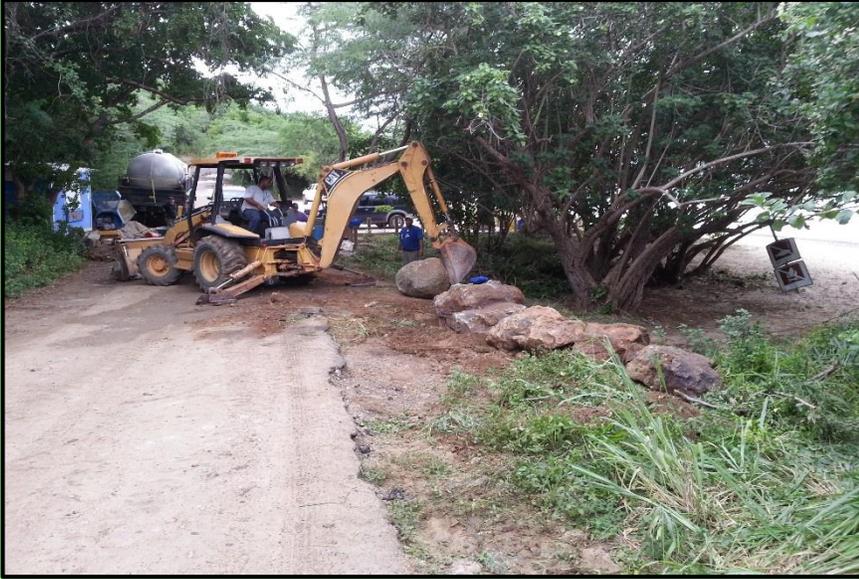
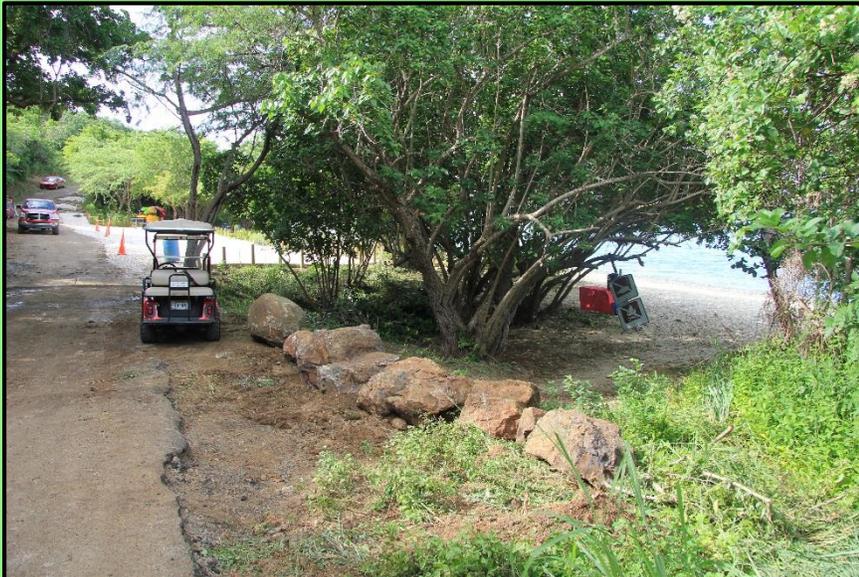
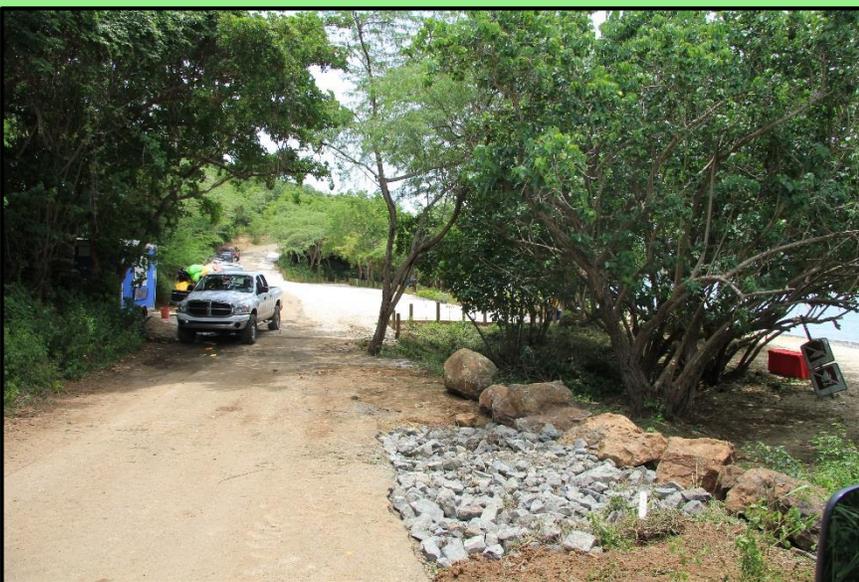
Sedimentation and erosion control practices established by the community.

Another aspect of our work was to stabilize and block an area sometimes used to access the beach with vehicles which also was an eroding conveyance of runoff from the access road to Tamarindo beach. The work in this section consisted of placing large rocks that surround the vehicular access and stabilizing the eroding access with large stone sized gravel to minimize erosion. The area was reforested with seedlings and emajagüillas. This section was designed and implemented by the Culebrenses, Omar Villanueva, Alexander Ayala and Tomás Ayala, who took part in a workshop on techniques for erosion and sedimentation control that we facilitated about a year ago in Culebra. The Ayala's were also volunteers in the effort providing their technical assistance and expertise to benefit their community. It was great to see the community leading the establishment of erosion and sediment control practices.

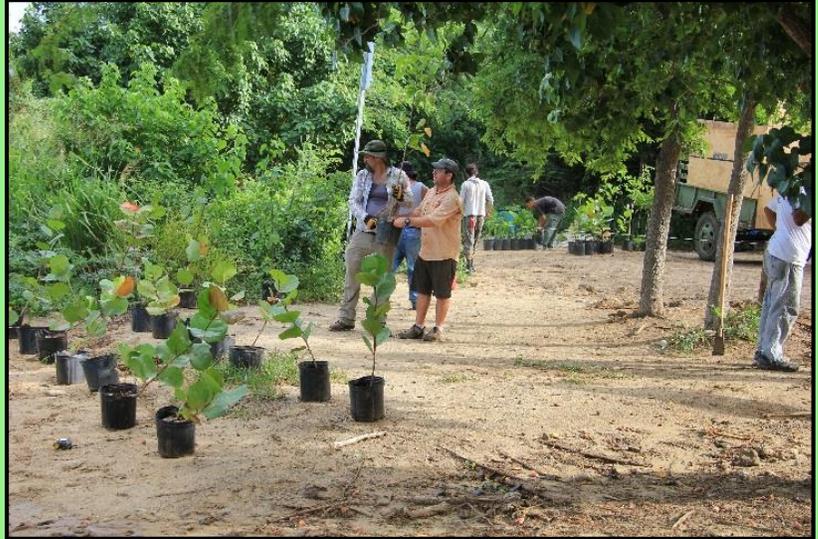
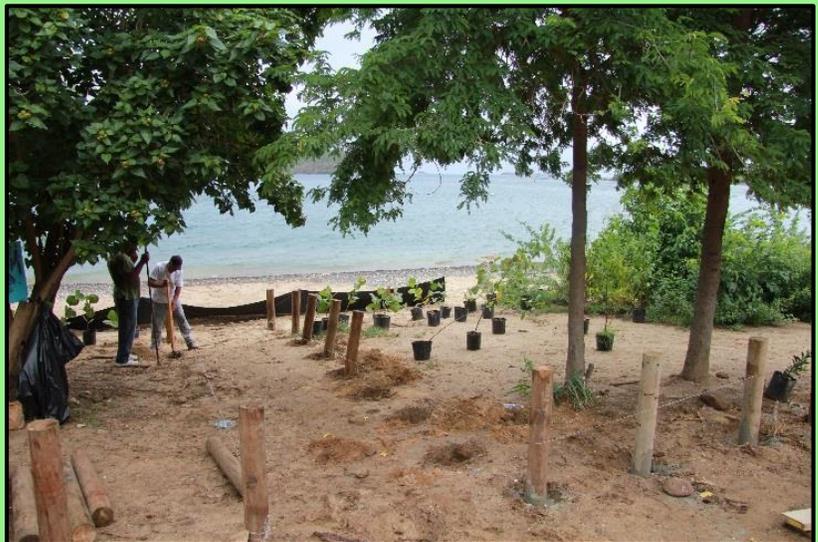
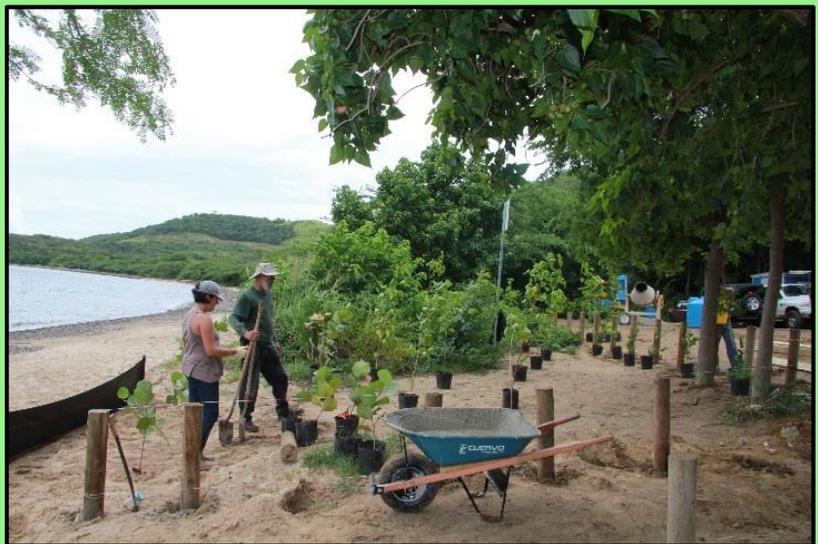
Design process to reforest areas.

The coastal habitat at Tamarindo beach had been seriously impacted by public uncontrolled public access and was in a very dilapidated state where the soil was compacted and eroding into the near shore waters. In order to restore the coastal vegetated berm and buffer, the team re-planted native species of endemic to coastal areas of Puerto Rico. Over 325 trees and shrubs were planted including a hundred sea grapes (*Cocoloba uvifera*), a hundred emajagüilla trees (*Thespesia populnea*), a hundred cooperwood (almácigo) seedlings (*Bursera simaruba*) and thirty icaco bushes (*Chrysobalanus icaco* L.). Furthermore, the project defined the pedestrian access areas to the beach. Reforested areas were delimited and access restricted primarily to three areas of public access. In two of these areas small elevated boardwalks were constructed for the public to access the beach without impacting vegetation and sand dunes. In the area closer to the coast the sea grapes planted at an average distance of one foot apart, and in two parallel lines

with the purpose of accelerating the accumulation of sand trapped by the wind. This process will increase the height and diameter of the sand dune. In the upper berm area, we successively planted emajagüillas and almácigos and between the parking area and division of permanent vegetation zone icaco bushes were planted. All trees planted were a contribution of DNER nurseries including Cambalache in Arecibo and the Mayagüez nursery. The plants and assistance were provided by the nurseries as part of the Sustainable Forestry Network. For irrigation at the restoration site, a 400 gallon cistern was installed in the area and the Municipality of Culebra has been filling it once a week.

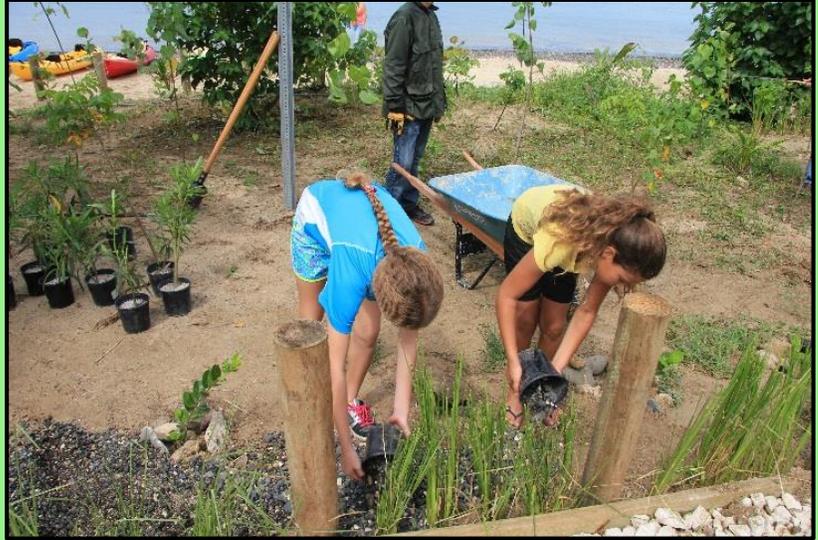
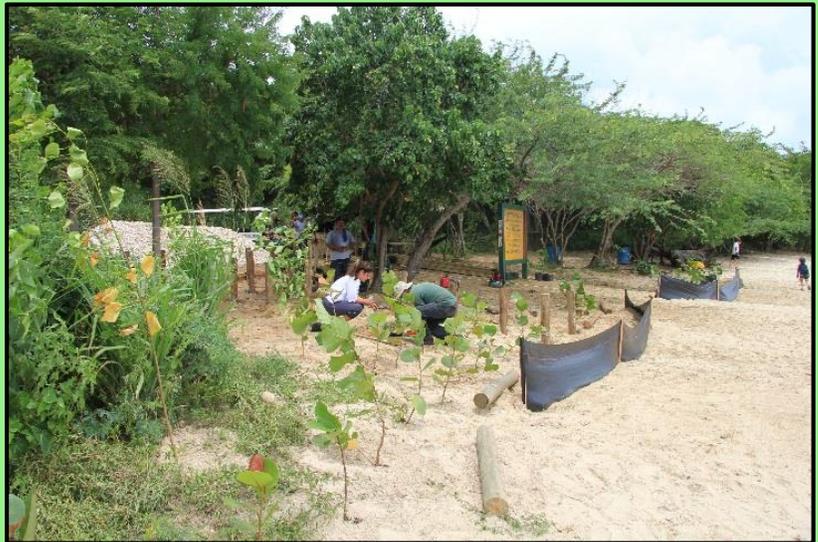
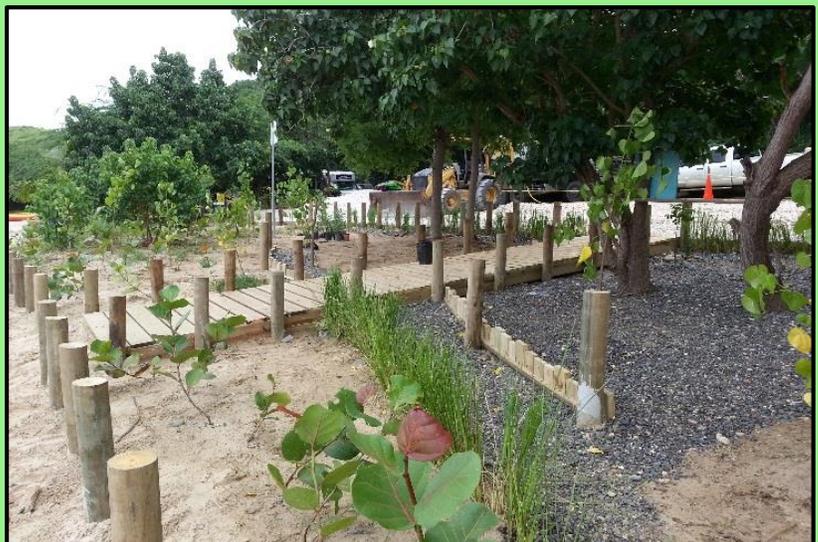
Reforestation process.

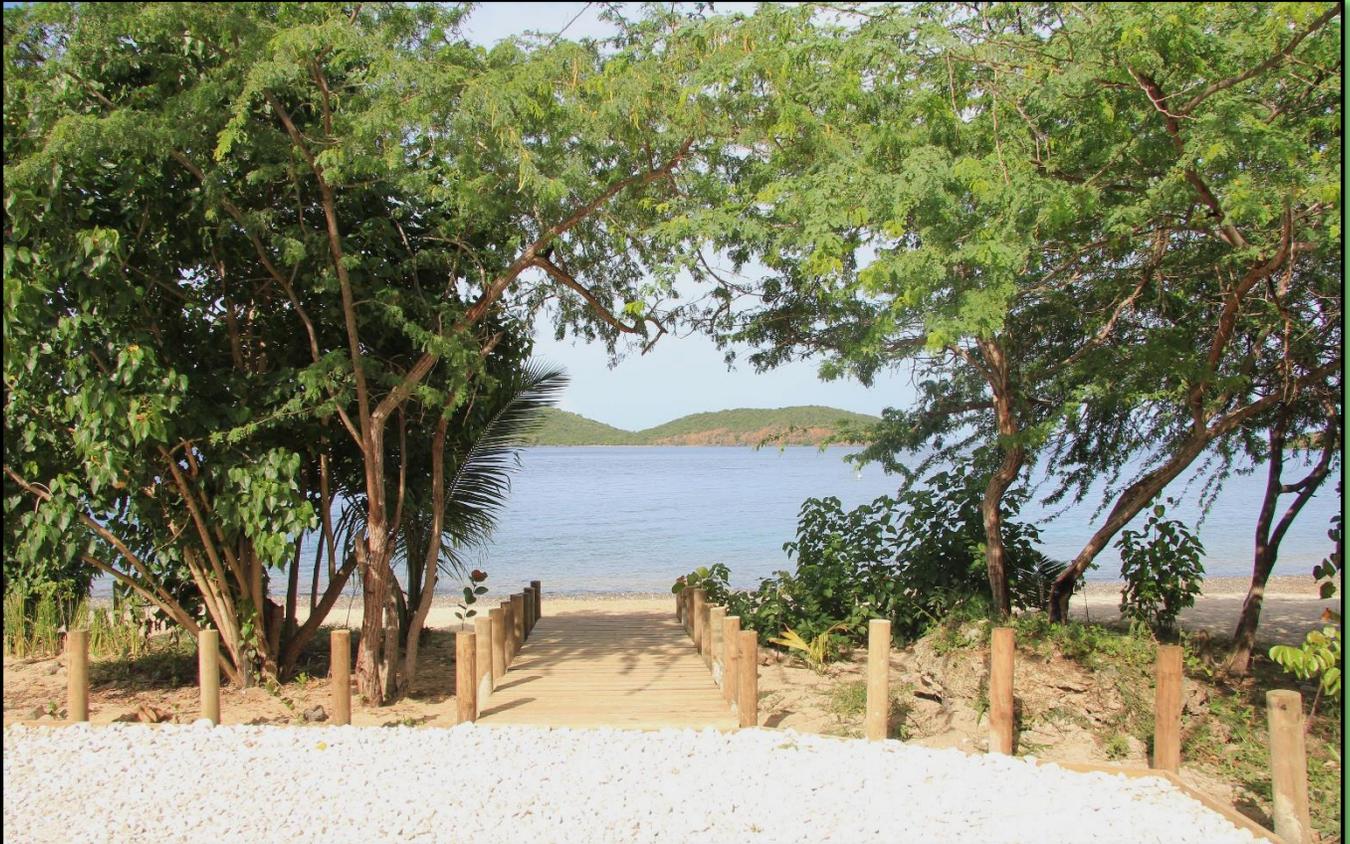
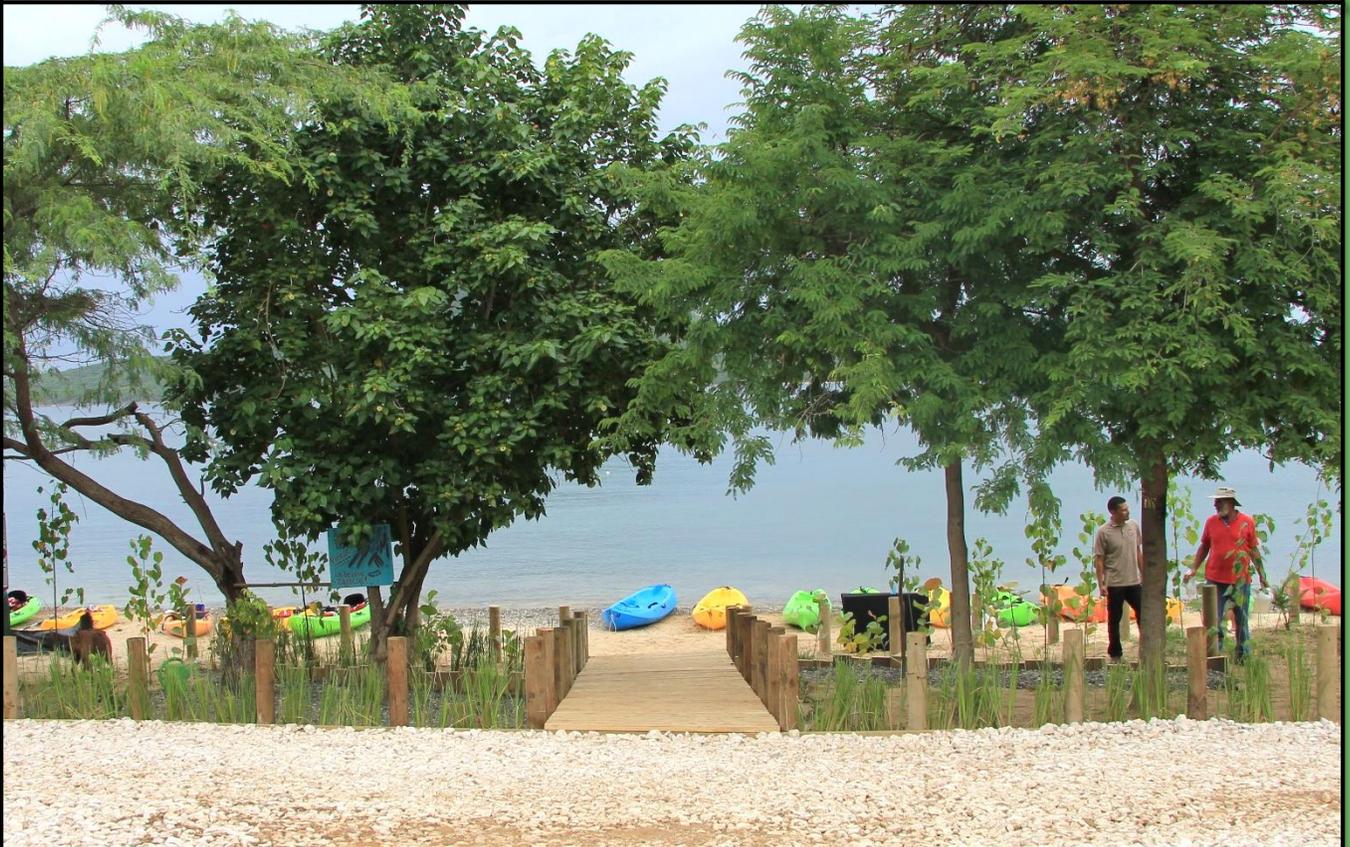
Boardwalks to delimit the beach access and protect the dunes and vegetation.

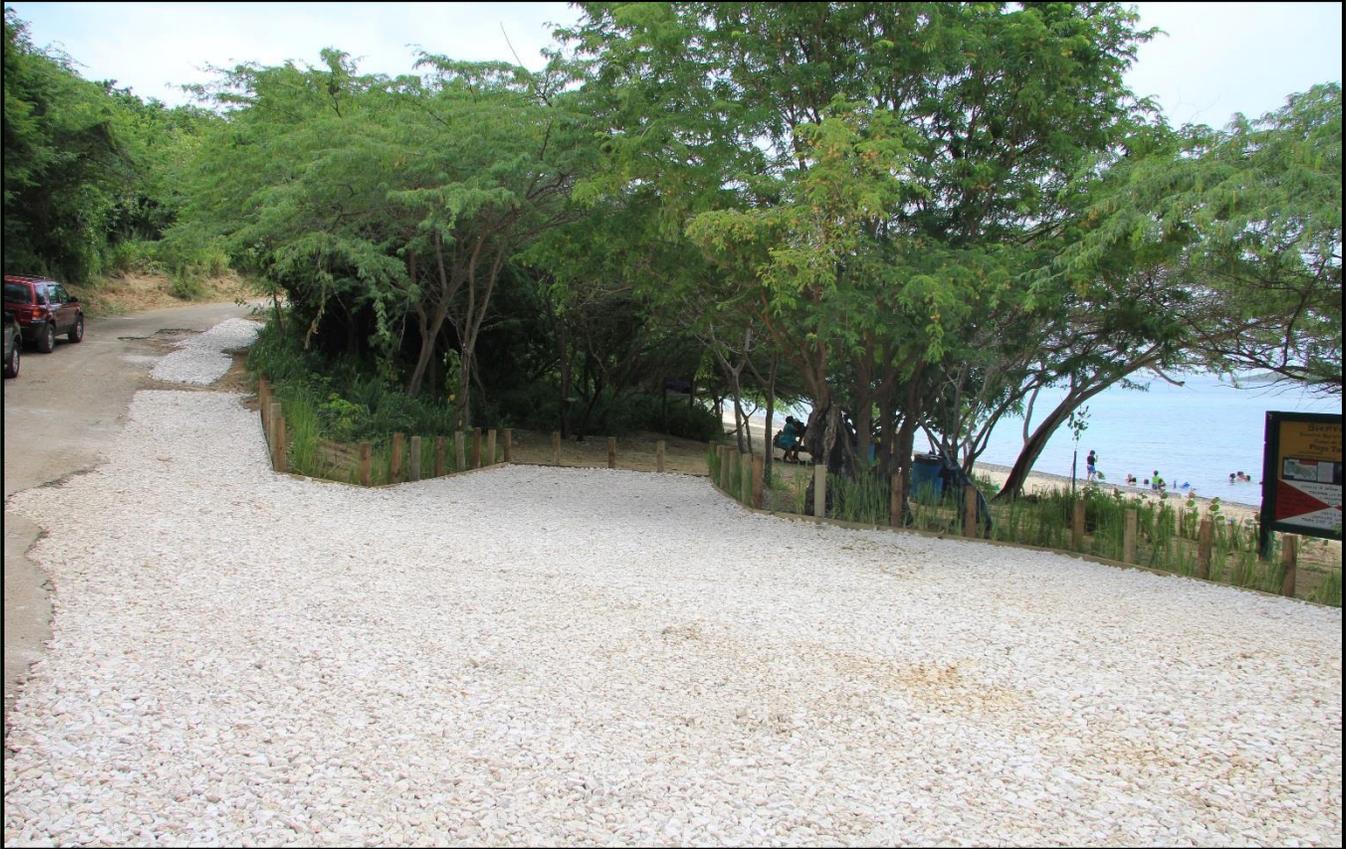
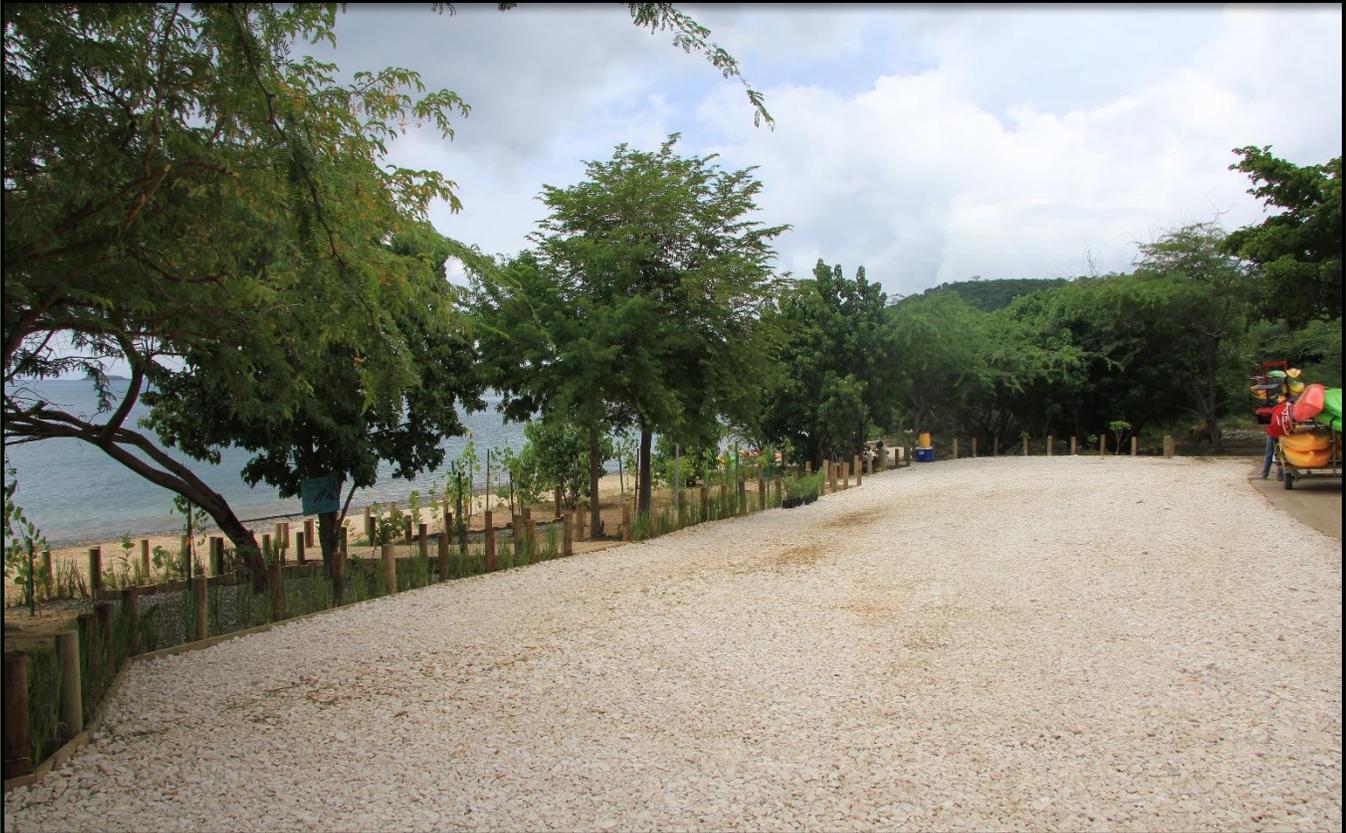
Images of the completed project.
