Environmental Restoration Project Playa Tamarindo Culebra, Puerto Rico Phase I

Roberto A. Viqueira Ríos
Louis G. Meyer Comas
Protectores de Cuencas, Inc.
Paul Sturm
Ridge to Reefs, Inc.
19 al 23 de agosto de 2013

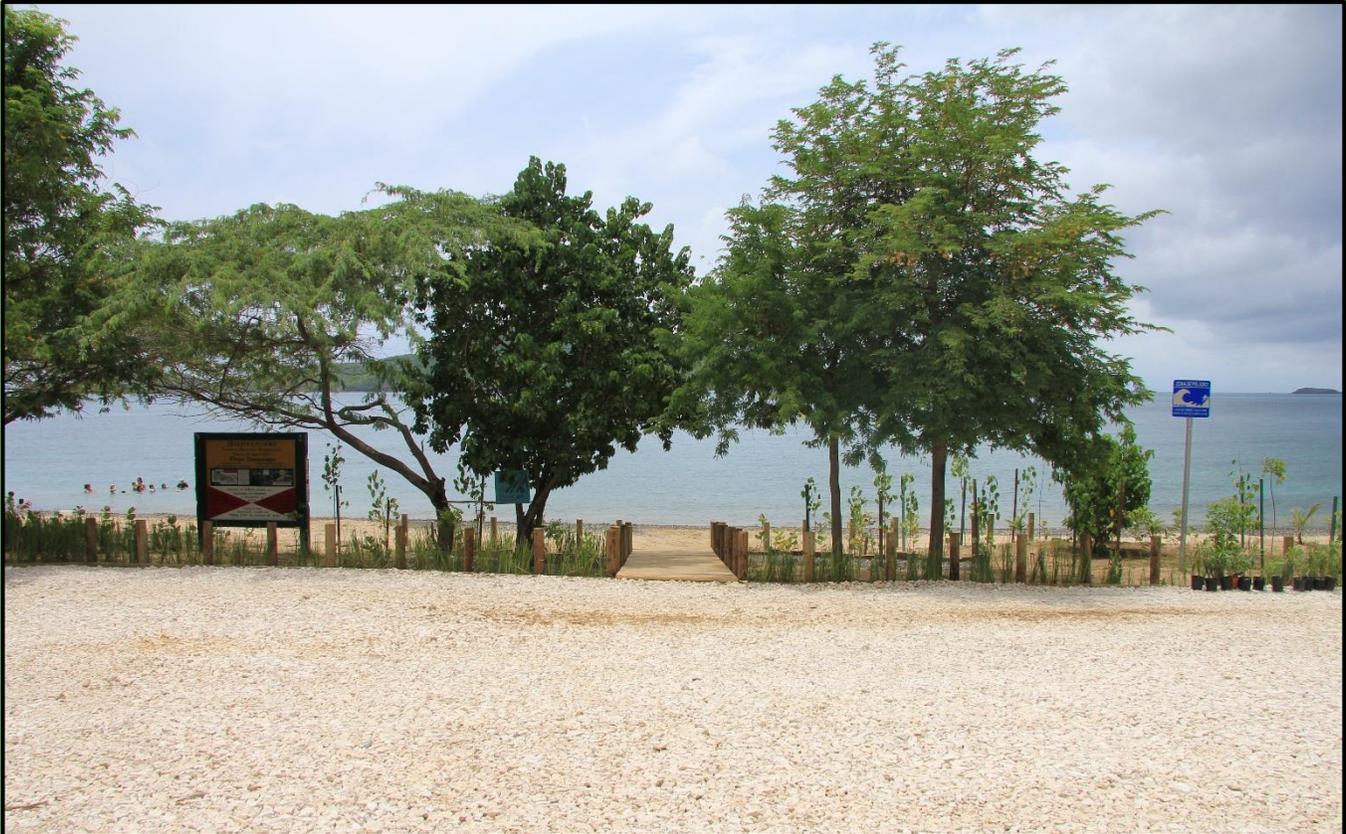
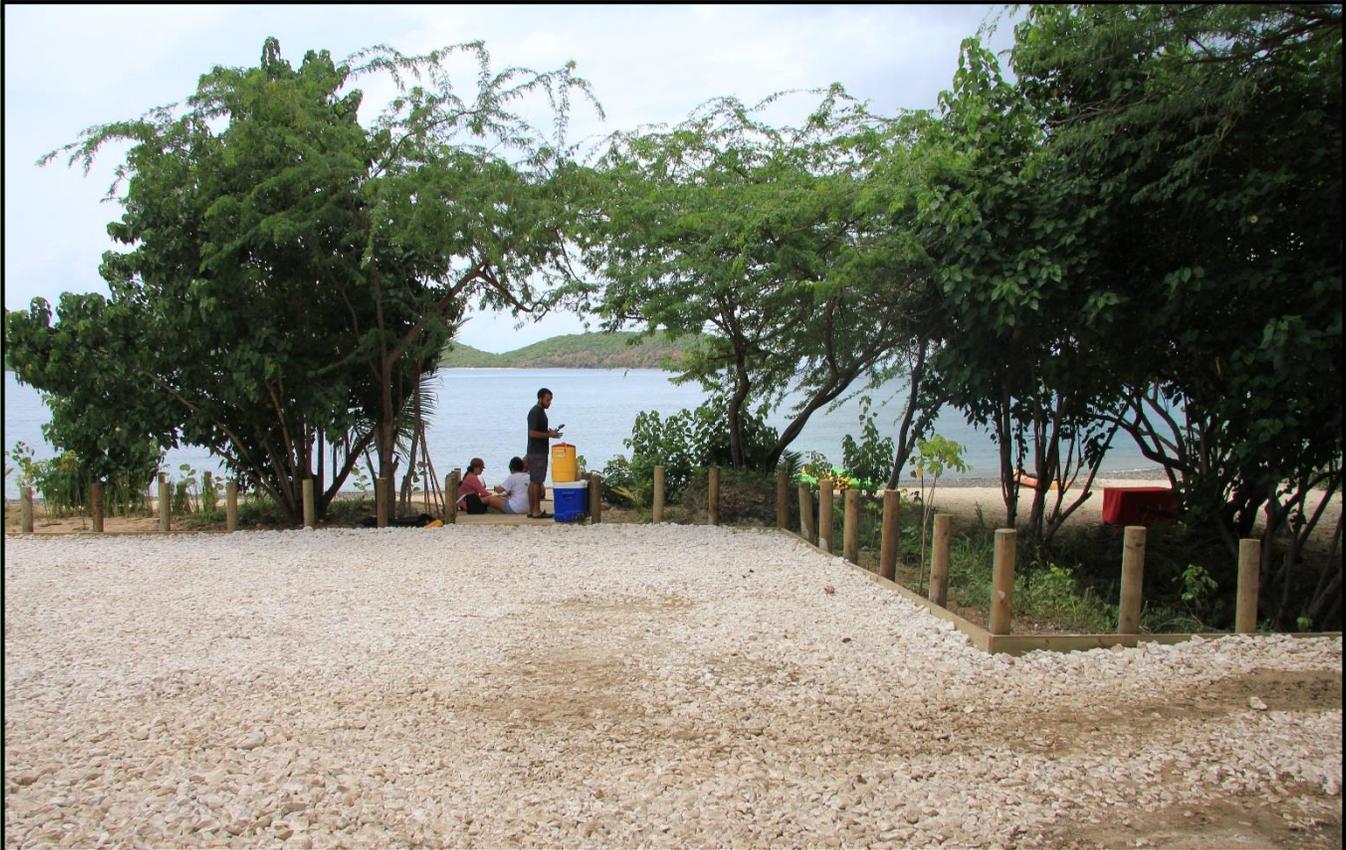
Images of the completed project.

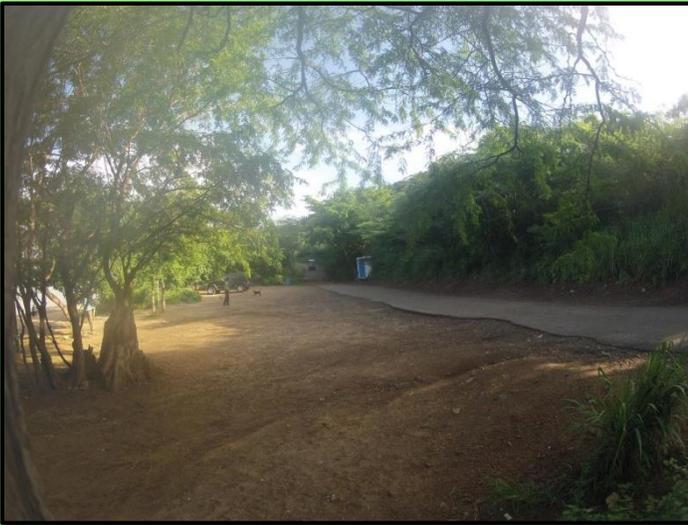
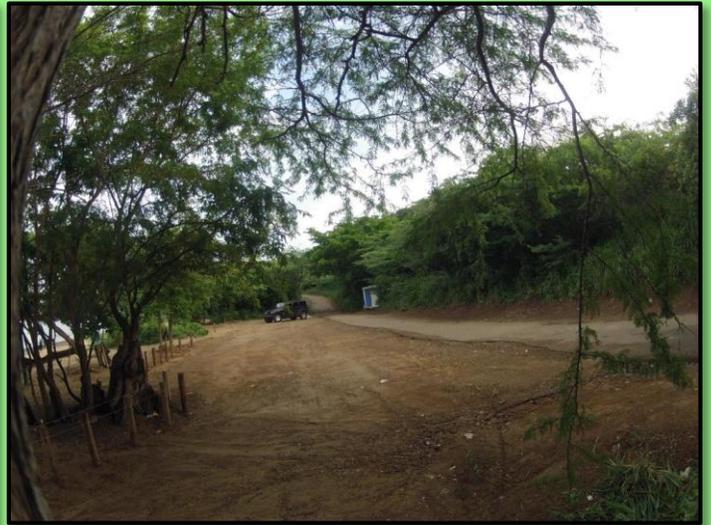
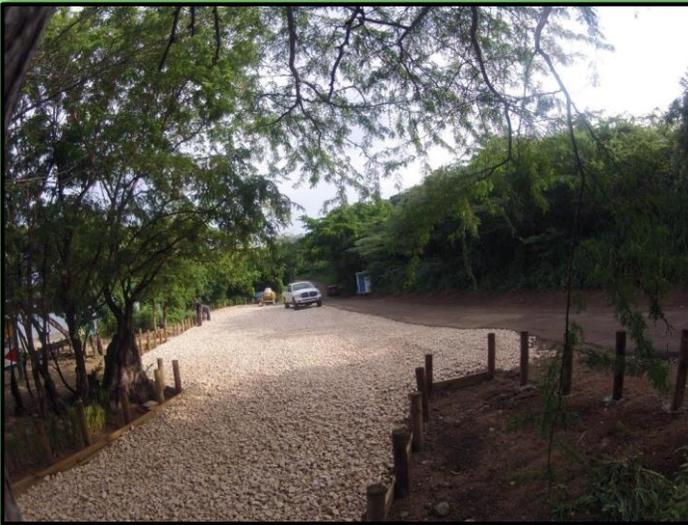
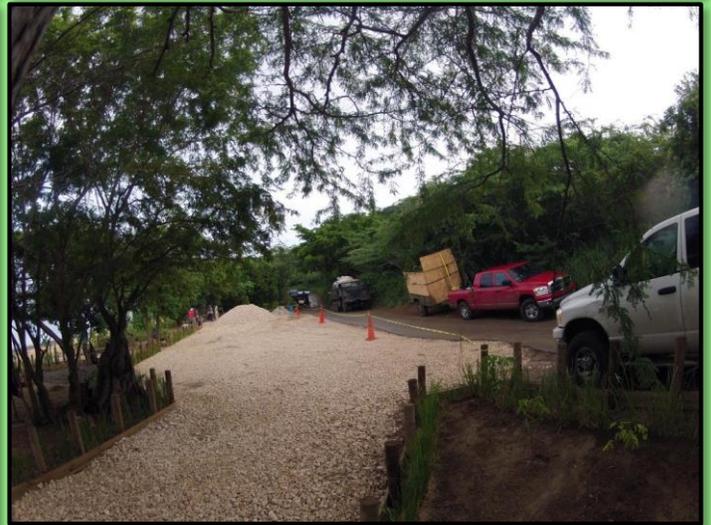
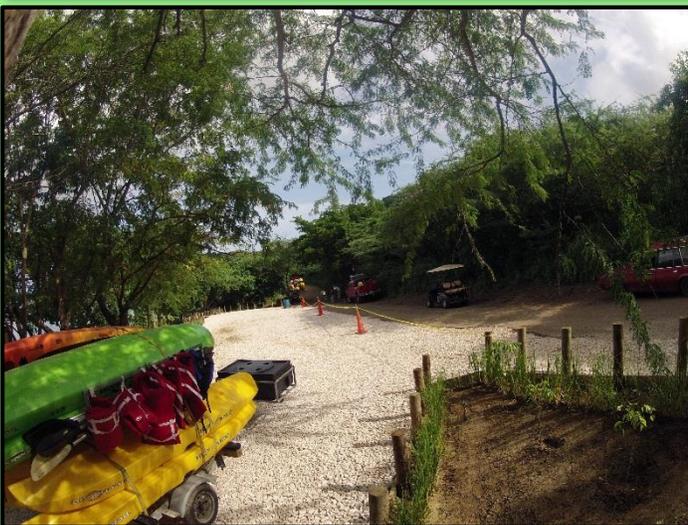
Images from a video camera located in the Project area during the process. From left to right, the pictures show the Project from day one to day five.
